Lessons learned on sand control failure, workover at Magnolia deepwater development

By George Colwart, Robert C Burton, Luke F Eaton, Richard M Hodge, ConocoPhillips; Kenyon Blake, Schlumberger

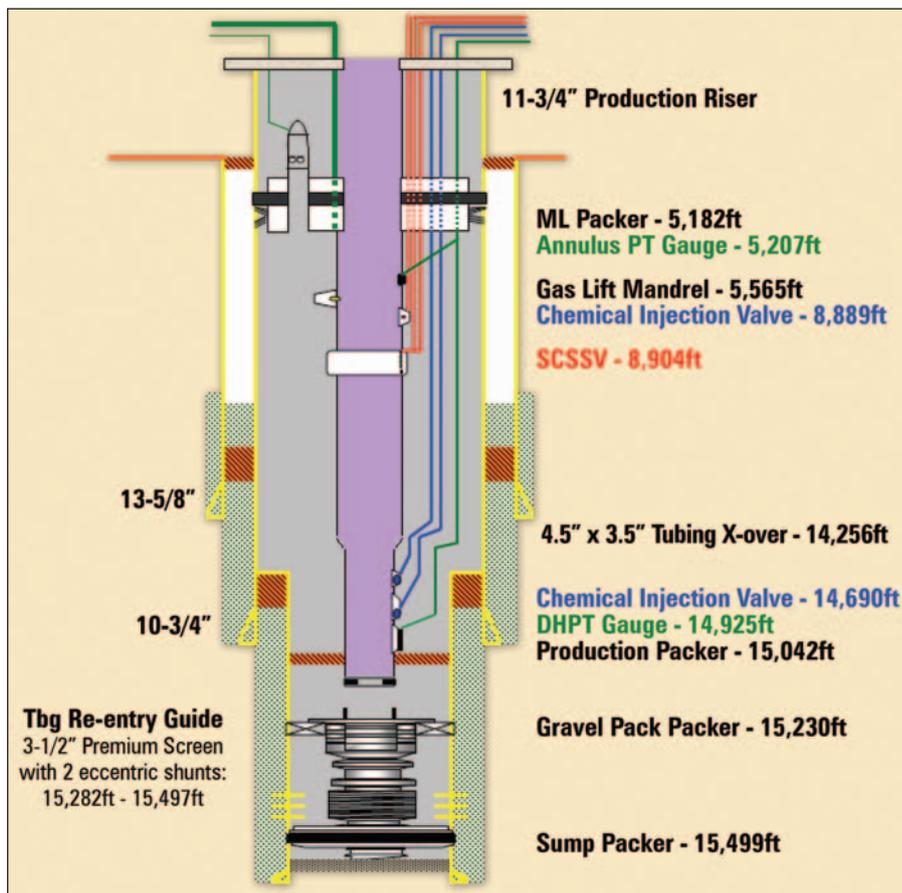
The 3rd well in the development of the Magnolia field in the Gulf of Mexico was completed using the same techniques as successfully used on the 1st 2 wells — yet failed. In a 2nd attempt, there was another apparent failure. Above is a simplified well sketch of the 3rd well, A1ST1BP1.

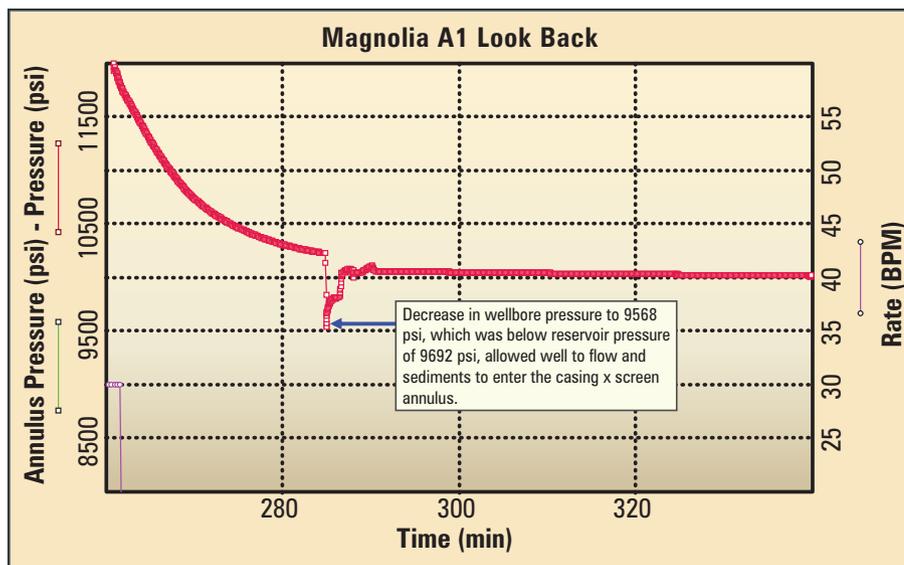
During completion operations, it was observed that while preparing to reverse out after the mini-frac, a valve behind the choke was inadvertently opened, allowing flow from the formation to the well for a short period of time.

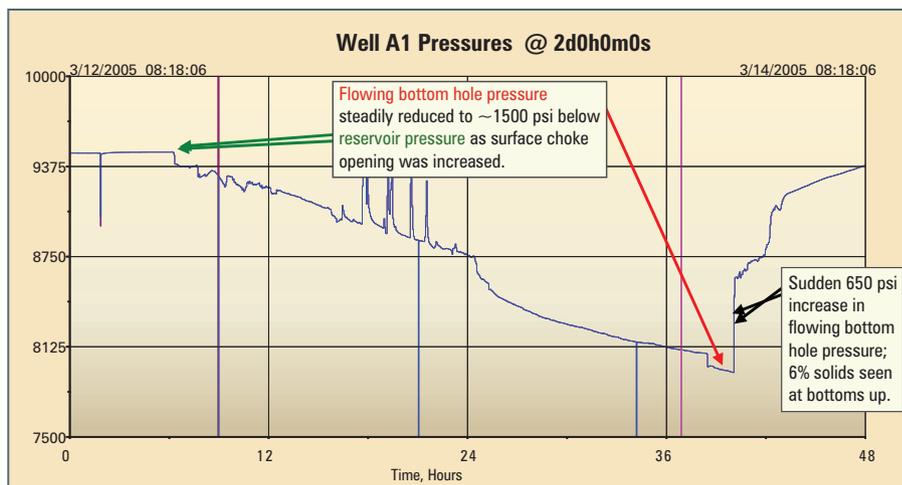
After the flowline choke opening was gradually increased to attain the scheduled rate, ultimately allowing a drawdown of about 1,500 psi at 2,000 bbl/day flow rate, a significant increase in flowing BHP was observed.

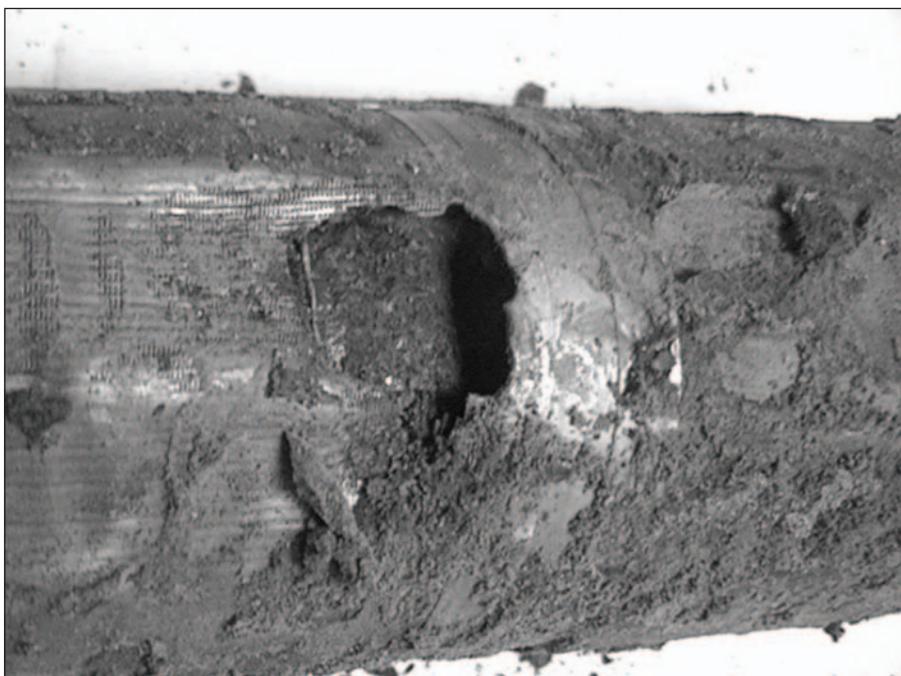
A short period of lost circulation was experienced while washing over the screens near the suspected screen failure depth. After washing over the screens down to the sump packer, the screens and shunt tubes were retrieved fully intact. One shunt tube was packed with formation sand. The outer layer of screen was packed with filter cake. The premium screen laminate had unexpectedly collapsed around the drainage layer underneath. A hole, with a diameter of about 2 in., was observed in the premium screen adjacent to an end ring.

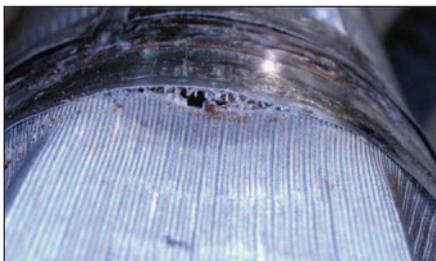
The first collapse test showed that the laminate layer began to collapse to the screen basepipe at a differential pressure of approximately 500 psi. Total failure occurred at a differential pressure of 950 psi. Upon removal of the shroud, the failure point was quickly identified (above). The failure point near the end ring was similar in appearance to the failure point identified on the screens that were fished out of the well.

From this testing, the probable downhole mode of failure of the premium screens was determined. The 1,500-psi differential pressure across the laminate layer during production caused the laminate

to collapse on the basepipe. Deformation of the laminate layer was limited to the annular space between the basepipe and the outer protective shroud. The deformation continued until reaching the end rings, which are much stiffer than the laminate layer. At that point, the laminate tore away from the end ring.

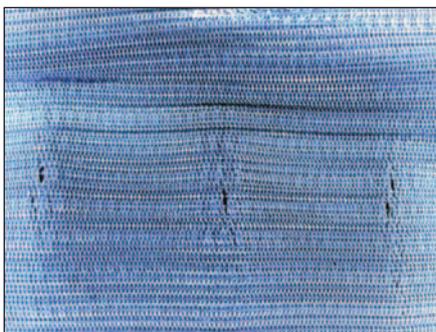
In the 2nd collapse test, total failure again occurred at around 950 psi, although the failure location was not as visually apparent. Rather than a large tear at the end ring, there were many small tears from the laminate layer stretching as it collapsed onto the drainage layer.

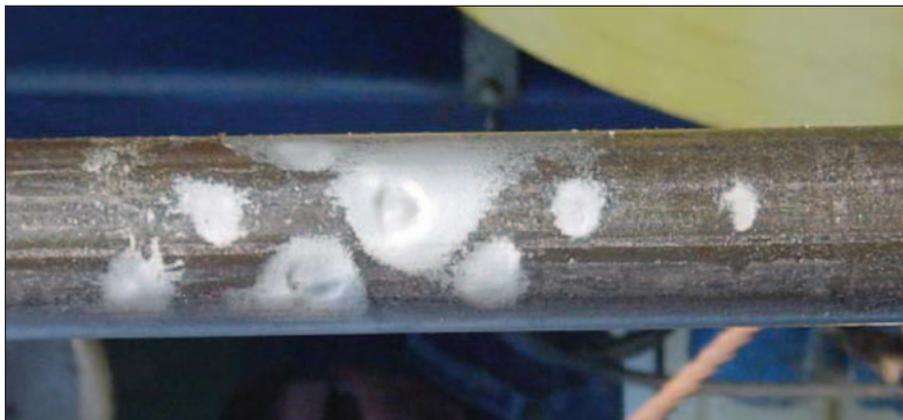
While circulating in packer fluid prior to pulling out of the hole after frac-pack operations, a slug of sand was observed at the shale shakers. When the service tool and washpipe were pulled out of the well, the washpipe was full of sand and proppant. In addition, scale on the outside of the lower 4 stands of the workstring appeared to be blasted off. The recovered washpipe showed severe erosion damage over roughly 180° of the circumference for a length of approximately 1 ft, suggesting high velocity flow of solids through the screen. The marks on the washpipe matched the pattern of holes on the screen's perforated basepipe.

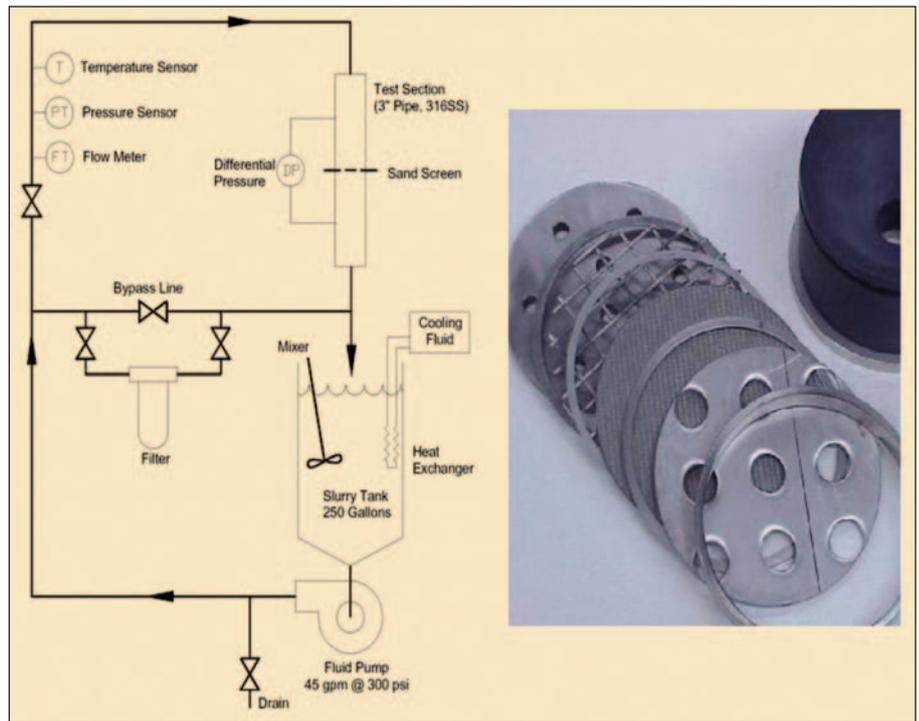
To determine the magnitude of flow required to cut out the screen, a series of erosion tests were conducted at a third-party test facility. The figure above shows the erosion test set-up.

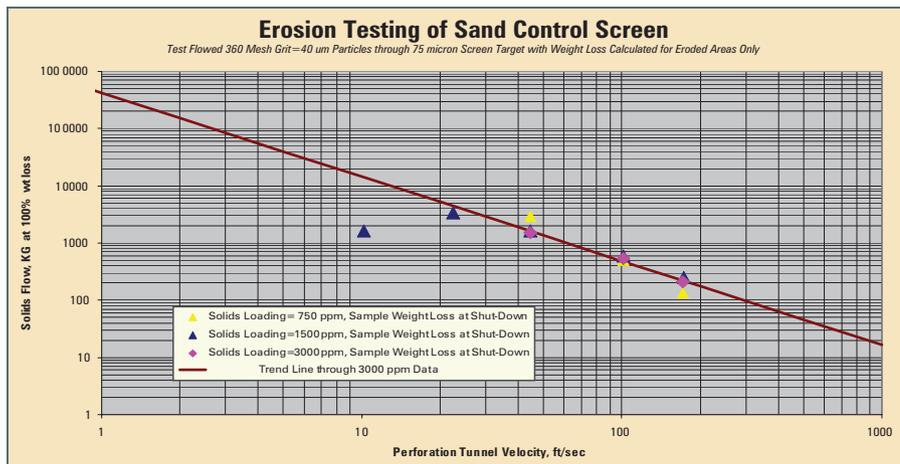
Using the trend-line shown in that figure, a fluid with high-solids loading flowing at a velocity of 100 ft/sec to 200 ft/sec could cut through a screen in a few minutes. While high, these types of flow velocities are consistent with high rate flow (9+ bbl/min) through a small area of screen (less than 1 ft of eroded washpipe with all erosion on one side).

Finding a source for formation solids small enough to fit through the 75 μ m screen without bridging is more problematic, but can be explained by noting the sand/shale interface opposite the screen failure. It is thought that the fine solids in the sand/shale interface could have produced solids small enough to flow through and cut out the screen before bridging.

The direct impingement erosion testing showed that the screen plugged off before any significant erosion occurred. Results of flow-through erosion testing showed severe erosion damage could occur if small particles flowed at high velocity through the screen. Using the trend-line shown in the graph above, a fluid with high-solids loading flowing at a velocity of 100-200 ft/sec could cut through a screen in a few minutes.
