Loss of well control incidents increase in GOM

John Kennedy, Contributing Editor

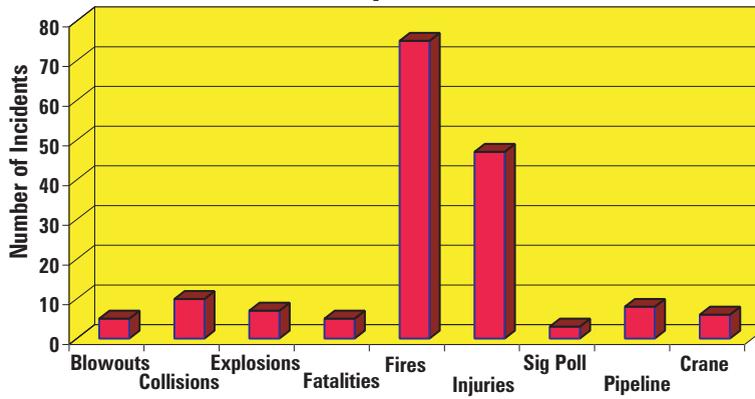
OCS events recorded by MMS in 1999

Source: US Minerals Management Service

Of all events recorded by MMS—blowouts, collisions, fatalities, fires, injuries, significant pollution, pipeline incidents and crane accidents—those that occur during drilling operations represent a small share.

In 1999, 54% of all incidents on the OCS
