Solutions offered for casing deformation problems

INTEGRITY OF THE CASING string is a fundamental requirement in any well. At the 2002 IADC/SPE Drilling Conference, 26-28 Feb in Dallas, a session on "Formation Driven Casing Design" explores casing deformation. The session is chaired by **M L Payne, BP plc**; and **D C Dupuis, Pride Forasol**.

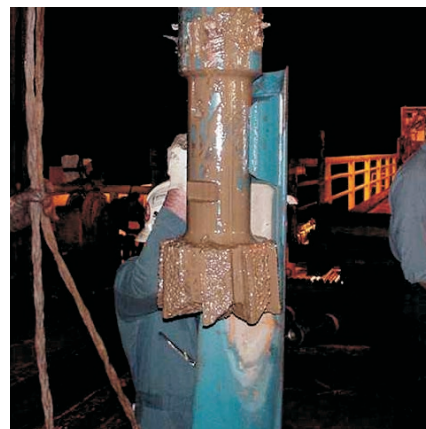
An 11 3/4-in. OD liner was installed through a whipstock window cut in the 13 5/8-in. casing.

A technological breakthrough in the well construction process was recently accomplished in the deepwater Gulf of Mexico. An 11 3/4-in. OD liner was successfully installed through a whipstock window cut in 13 5/8-in. casing. It was the first attempt to run casing larger than 9 5/8-in. OD through a 13 5/8-in. window.

The casing program of the original well and the proposed bottomhole location of the sidetrack dictated that the well be kicked off below the 16-in. casing shoe.

The evaluation program of the sidetrack hole included a conventional core and it was determined that a minimum hole size of 8 1/2 in. was required to cut and recover a core large enough for evaluation. Well operations dictated that the 11 3/4-in. liner be run through the 13 5/8-in. window to achieve the desired 8 1/2-in. hole size at total depth. ■
